## Institute of Refrigeration

### Valve Failure Safety Alert

### Valve failure results in ammonia refrigerant burn injury

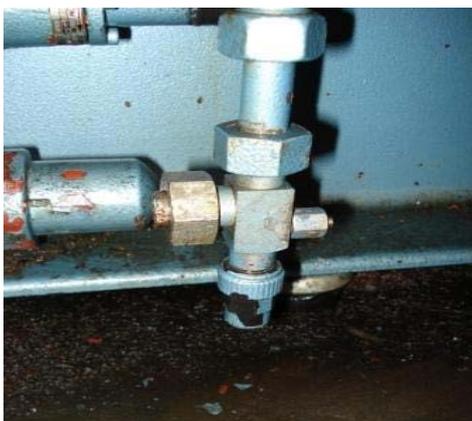
The valve construction included steel pipe stubs brazed into the valve body, screwed connections with nuts on the other end of the pipe stubs allow the valves to be connected to the systems or have blanking caps fitted. The valve that failed was connected to the system using a nut on the stub 90° to the valve stem; this stub came apart from the valve body. The second stub in line with the valve spindle had a blanking nut fitted as it was the refrigerant charging connection.

Valves with these types of brazed in connections are available in a range of sizes and are widely used on refrigeration systems. The photograph

shows a typical valve (not the actual which failed); in this application the blank is on the stub at 90° to the valve stem and plant connection is in line with the valve spindle.

- The failure was due to corrosion under the preformed brazing filler metal thus weakening the joint on to the valve parent metal.
- The corrosion had started externally.
- The valves were fitted on a section of plant cycling from sub zero to above zero temperatures.
- Forces used prior to the incident to fit the valves, remove caps or to fit charging lines etc may have damaged the valve.
- The paint finish on the valves had deteriorated.
- Ammonia was not considered to be a factor in the failure and it is believed that a serious incident would have occurred regardless of the type of refrigerant in the system.

- Before commencing work on any Refrigerating system wear PPE as required by your employers' Risk and COSHH assessments for the refrigerant within the system PLUS in the case of Ammonia have a respirator available and to hand.

- When working on any type of valve with screwed connections always use a check spanner to hold the body of the valve whilst undoing connections, caps, plugs, etc, with another spanner.

- Identify all refrigeration plants containing these types of valves installed in parts of the system susceptible to corrosion e.g. regular cycling from sub zero to above zero temperatures or frequent operation in a wet condition. Then DO NOT ATTEMPT to use the valves until an appropriate risk assessment is carried out for either the replacement or the continued operation of the valves.

- When working on refrigeration plants fitted with these types of valves installed and operating in dry conditions such as in HP discharge or liquid pipe lines etc, DO NOT ATTEMPT to work on the valves without firstly isolating upstream and downstream of the valve in order to limit potential gas loss.

- Clean and apply refrigeration oil to threads before replacing screwed connections.
- Regularly (quarterly) examine valves for leakage and corrosion and repair, paint or replace as required.

- Consider if insulation is required to prevent ice from building up around the valve and exerting forces on the pipe stubs.
