## Institute of Refrigeration

## Valve Failure Safety Alert

### Valve failure results in ammonia refrigerant burn injury

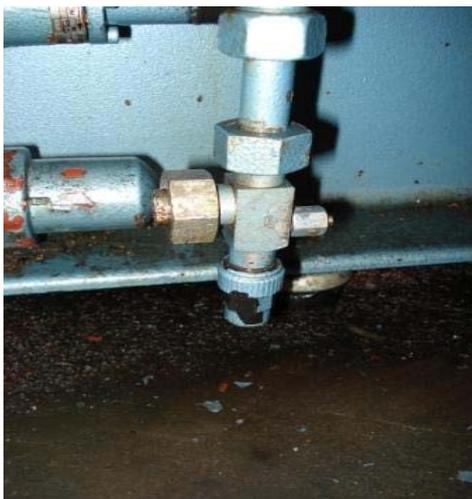
Valves with these types of brazed in connections are available in a range of sizes and are widely used on refrigeration systems. The photograph below shows a typical valve; in this application the blank is on the stub at 90o to the valve stem and plant connection is in line with the valve spindle.

- The failure was due to corrosion under the solder thus weakening the joint on to the valve parent metal.
- The corrosion had started externally.

- The valves were fitted on a section of plant cycling from sub zero to above zero temperatures.
- Forces used prior to the incident to fit the valves, remove caps or to fit charging lines etc may have damaged the valve.
- The paint finish on the valves had deteriorated.
- Ammonia was not considered to be a factor in the failure and it is believed that a serious incident would have occurred regardless of the type of refrigerant in the system.

- When working on any type of valve with screwed connections always use a check spanner to hold the body of the valve whilst undoing connections, caps, plugs, etc, with another spanner.

- Identify all refrigeration plants containing these types of valves installed in parts of the system susceptible to corrosion e.g. regular cycling from sub zero to above zero temperatures or frequent operation in a wet condition. Then DO NOT ATTEMPT to use the valves until an appropriate risk assessment is carried out for either the replacement or the continued operation of the valves.

- When working on refrigeration plants fitted with these types of valves installed and operating in dry conditions such as in HP discharge or liquid pipe lines etc, DO NOT ATTEMPT to work on the valves without firstly isolating upstream and downstream of the valve in order to limit potential gas loss.

- Clean and apply refrigeration oil to threads before replacing screwed connections.
- Regularly (quarterly) examine valves for leakage and corrosion and repair, paint or replace as required.

- Consider if insulation is required to prevent ice from building up around the valve and exerting forces on the pipe stubs.
